Northstar Model N222 Detectors

Presented by:
Milton I. Dean, PE

Metal Pole Span Attachment

LED Signal Module Replacements

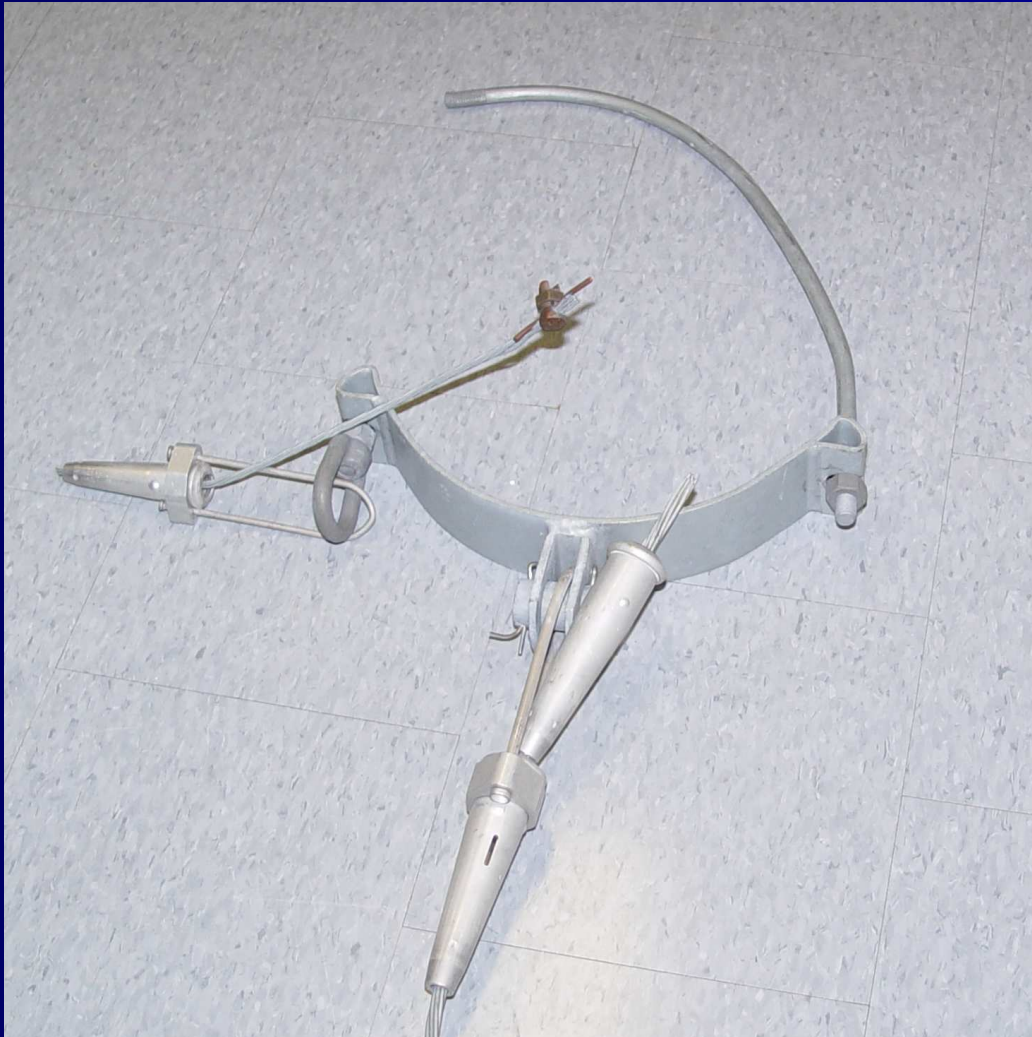
Division 6 Failure (2003)

Note thimble-eye nut was attached to threaded u-bolt. The weight of the communication span caused the threaded portion of the bolt to fail causing the signal head span to fall.

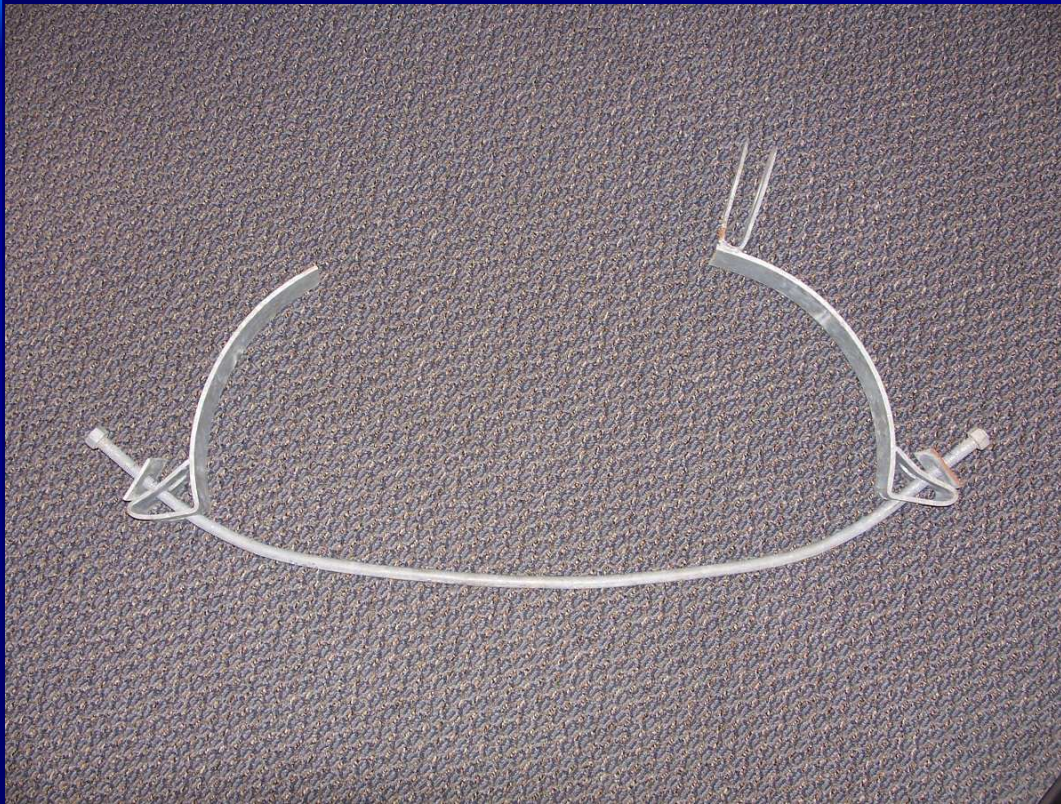
Division 2 Failure (2010)

Formed band failed at the weld. Materials and Test indicated some concern about the welding process. Further review revealed two signal spans were attached to this one clamp.

- Noted problem of recent failure in Division 2
- Requested each Division to check their poles
- Divisions requested to take corrective measures where multiple spans were attached to one pole clamp

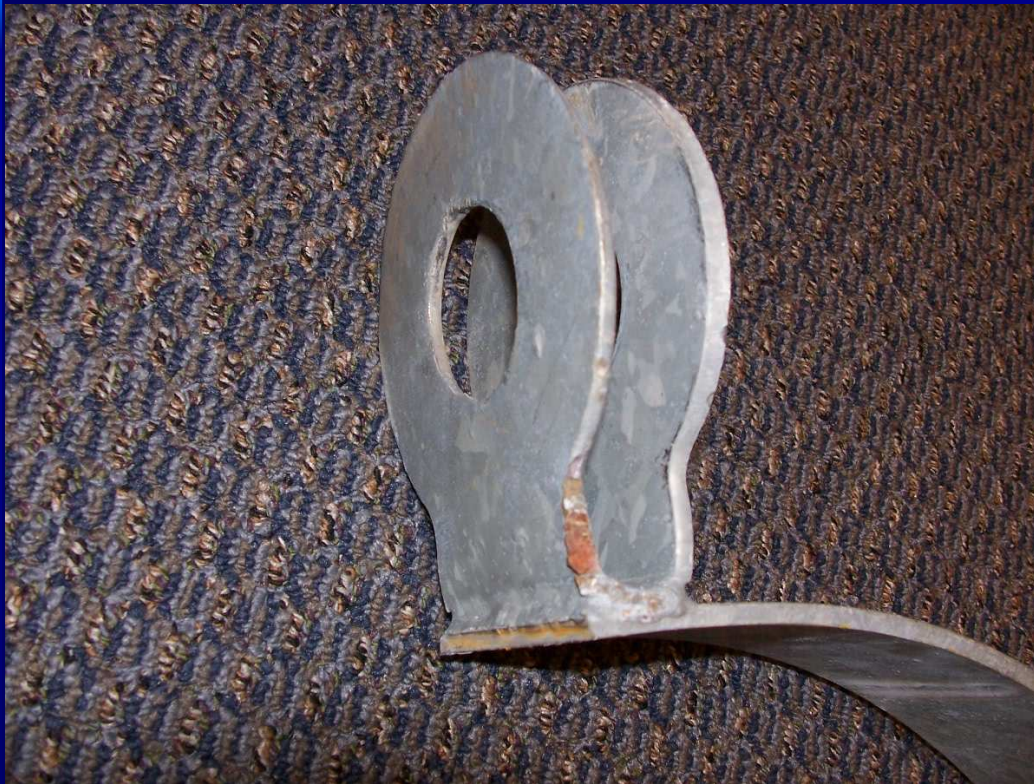
Division 2 Failure

Further review revealed two signal spans were attached to this one clamp.

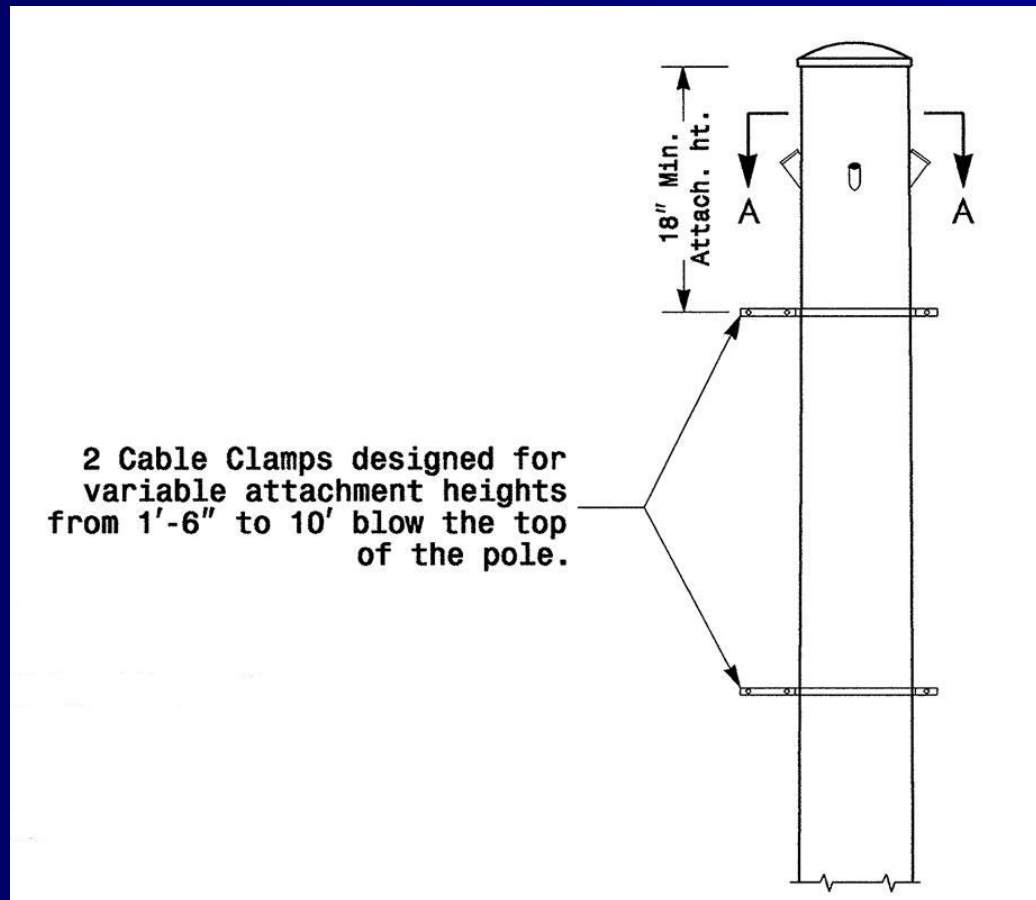
Metal Pole Drawing M3

Drawing requires 2 pole attachment clamps for each pole.

For each strain pole, provide 2 messenger cable (span wire) clamps and associated hardware for attachment of support cable of the messenger cable suspension. Ensure that diameter of the clamp is appropriate to its location on the pole and that the diameter of the clamps is appropriately designed to be adjustable from 1'-6" below the top, down to 6'-6" below the top of the pole. Do not attach more than one support cable to a messenger cable clamp.
